Improving the System Life of Basic Oxygen and Electric Arc Furnace Hoods, Roofs and Side Vents

Nathan Goebel
Division Manager, Steelmaking
Republic Engineered Products

Cleveland, OH
January 23, 2008

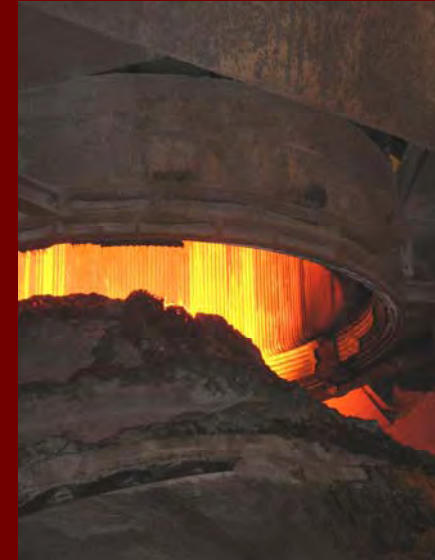
Ameribronze Performance History

⇒ Skirt

⇒ Installed Oct. 2004 (~ 39 mo)

⇒ Removed (System Repair) – 10/06

⇒ Back in Service – 01/07

⇒ ~ 7000 Heats (1/1/08)

⇒ Planned and Unplanned Maintenance

THREE TIMES (1 Planned)

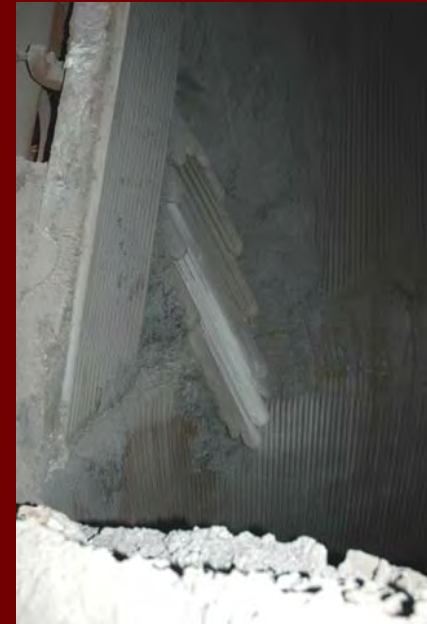
Ameribronze Performance History

⇒ Flux Chute

⇒ Installed May 2006 (19 mo)

⇒ ~ 5500 Heats (1/1/08)

⇒ Planned and Unplanned
Maintenance

NONE

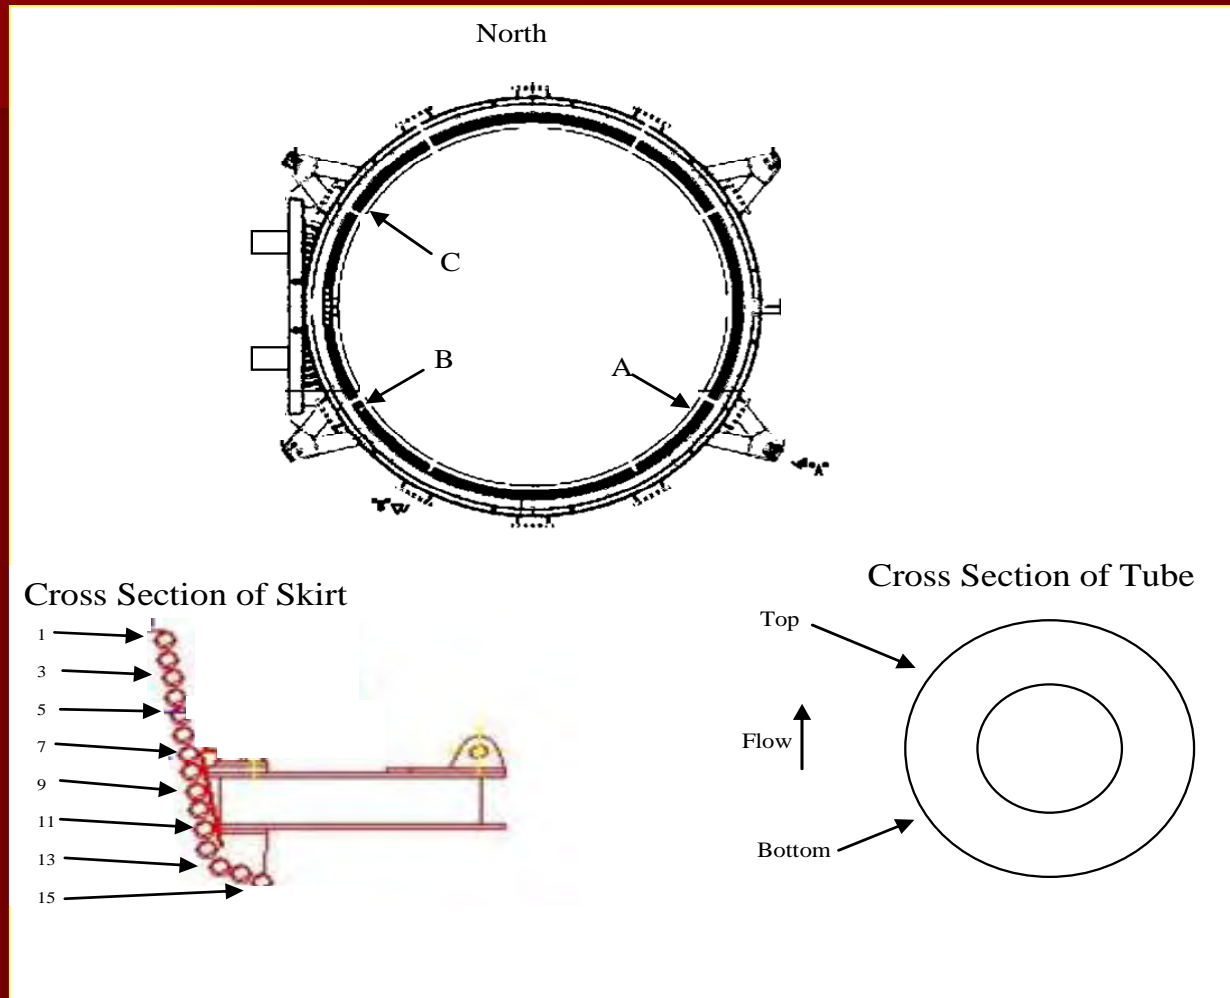
Thickness Measurements

During 10/06 System Repairs (4563 Heats)

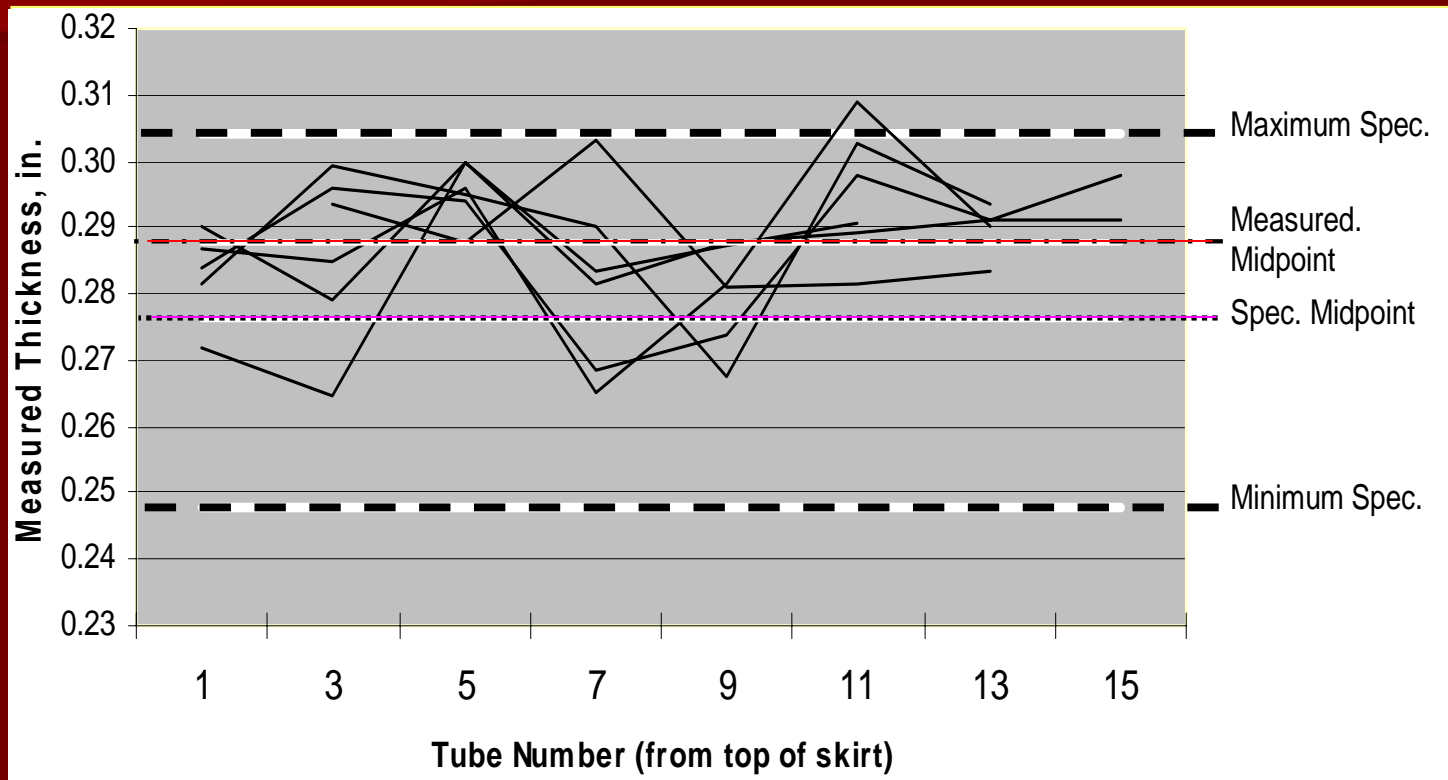
Thickness Measurements

During 10/06 System Repairs (4563 Heats)
